NONDESTRUCTIVE EVALUATIONS OF COM-
POSITE HEATSHIELD MATERIALS BEFORE
AND AFTER AN UNDERGROUND NUCLEAR
EXPOSURE

James R. Brown, Jr., et al

Southern Research Institute

AFWL-TR-73-247

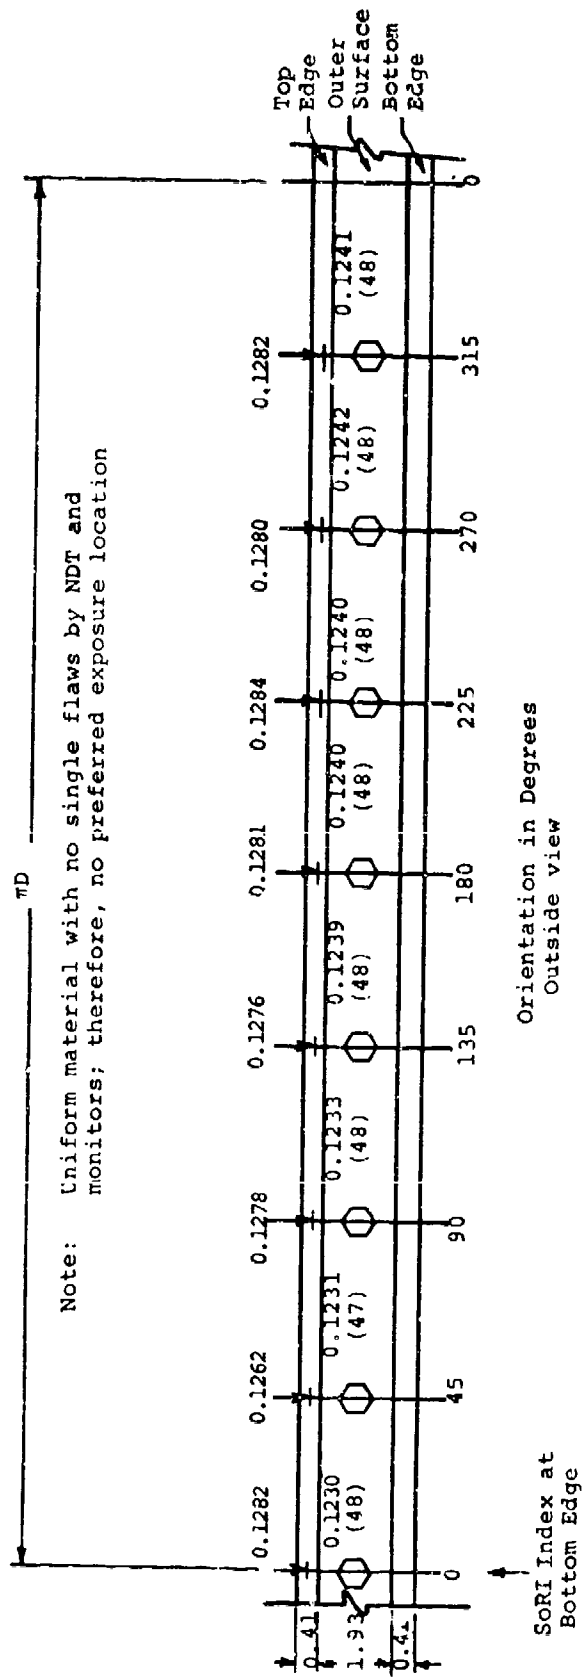
Figure 11. Sketch Showing Inspection Results on Ring 83301-400 from AVCO R6300

Some structural change was indicated in exposed Rings 83301-305-1 and 83301-400 by visual, X-ray, and liquid penetrant inspections. For 83301-305-1, the change was visually apparent matrix damage on the front face (outer surface) of the exposed area, Figure 14. Also, increased porosity to a depth of 100 mils on the rear face (inner surface) of the exposed zone was visually apparent. For 83301-400, the only change detected was increased porosity to a depth of 80 mils on the rear face (inner surface) of the exposed zone. No change was detected in Ring 83301-305-4.

Radial Velocity in in./μsec
(Relative Radial Transmission in added dB)-Higher readings correlate lower attenuative material
2. + Axial Velocity in in./μsec
3. Visual and penetrant inspection revealed no flaws
4. Radiography revealed uniform material with no single flaws
5. Density - 1.339 gm/cm³

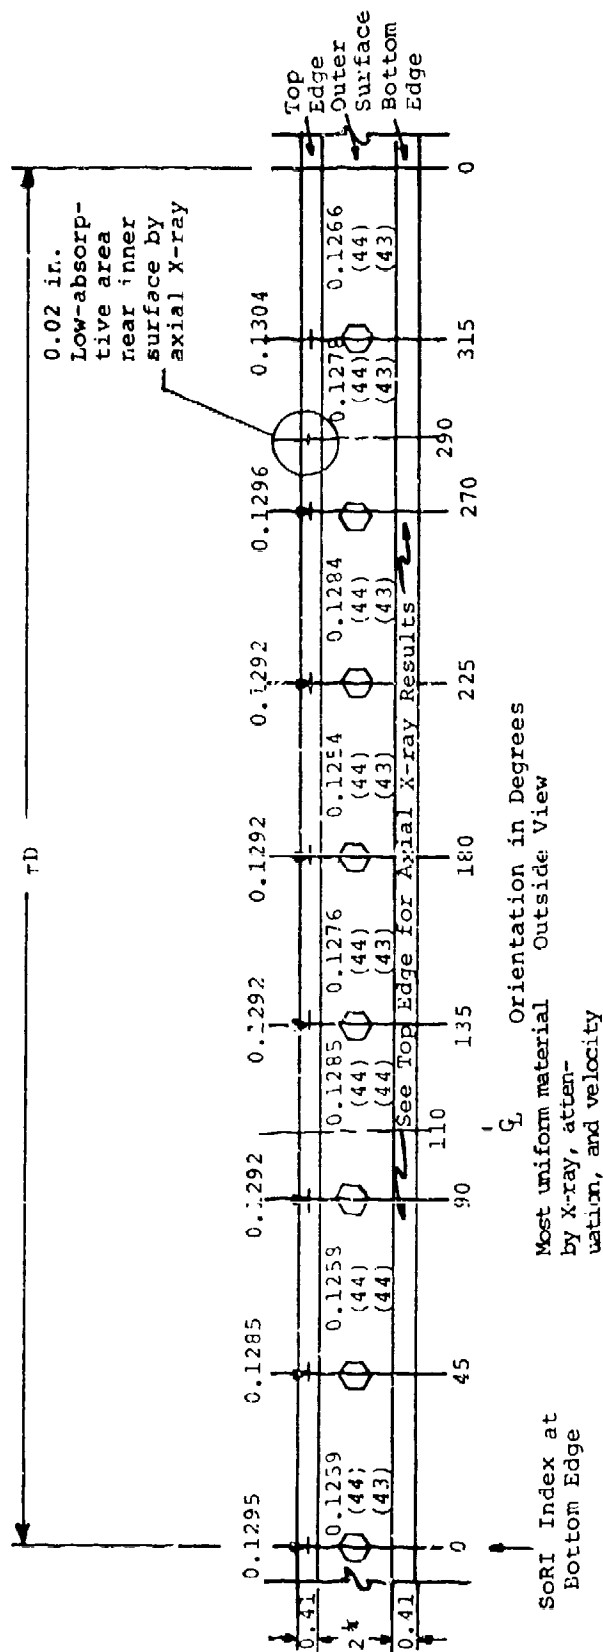
Figure 13. Sketch Showing Inspection Results on Ring 83301-305-1 from AVCO R6300

Radial velocity in in./usec
(Relative radial transmission in added dB) - First Run { Higher attenuation readings correlate
(Relative radial transmission in added dB) - Second Run { lower attenuative material
2. \downarrow Axial velocity in in./usec
3. Visual inspection results - no single flaws
4. Penetrant inspection on edges using 2, 2, 4 - Trimethylpentane - no single flaws

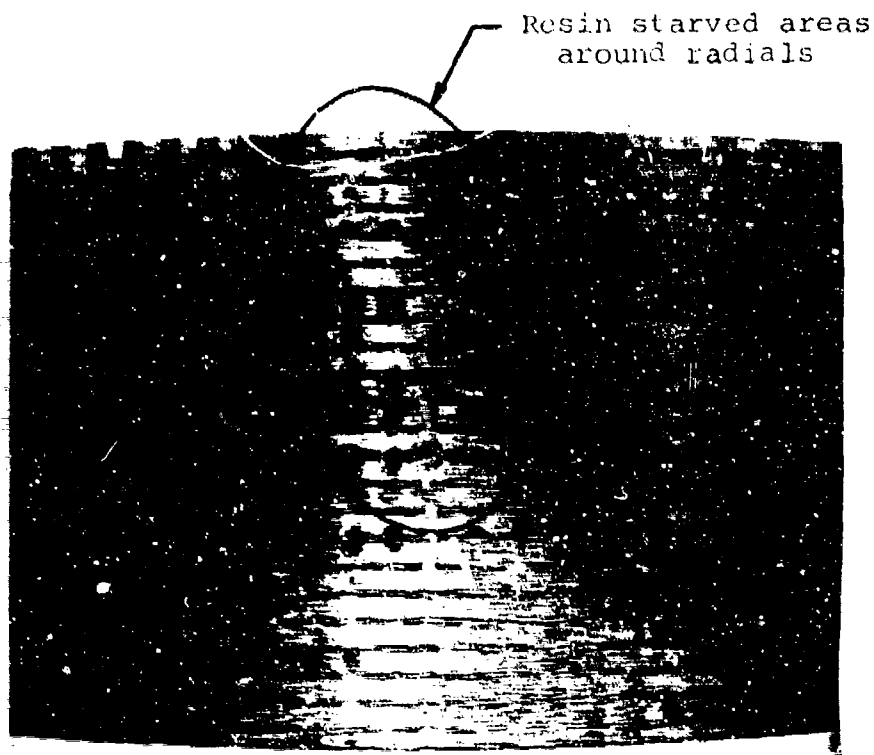
Figure 17. Photograph Showing Visual Resin-
Starved Areas Around Radials in
Ring 2 from AVCO 3DCP

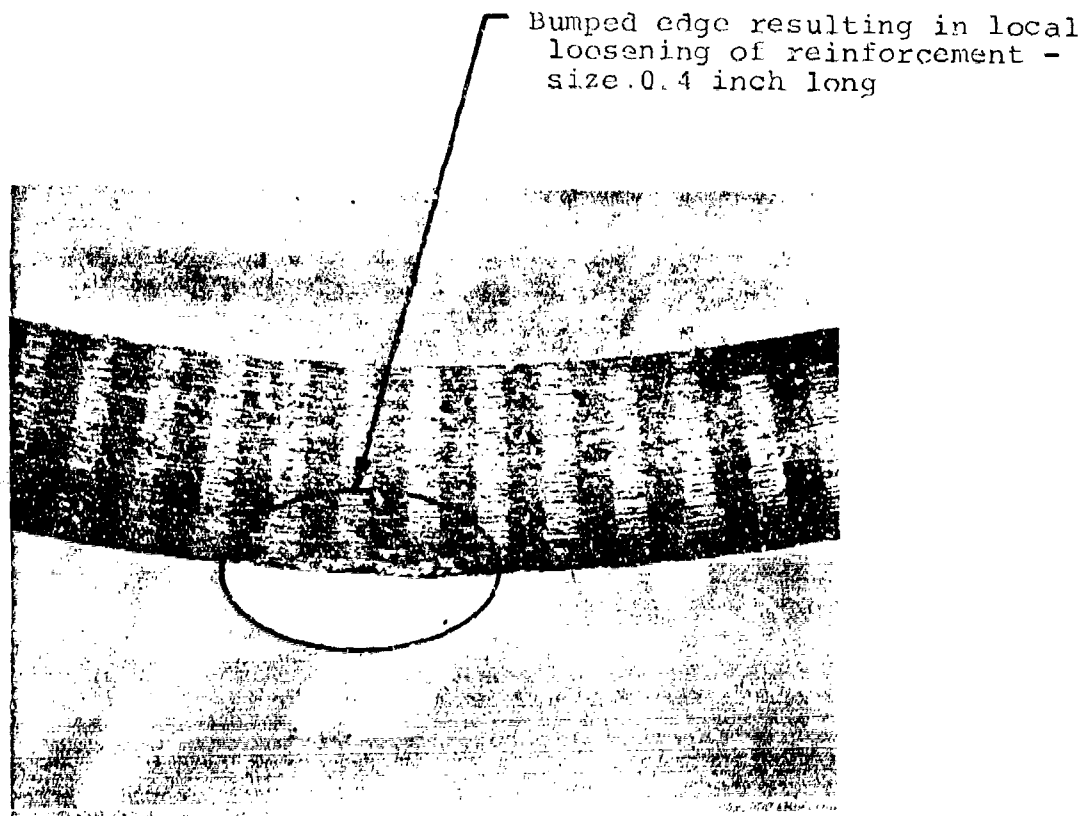
Figure 18. Photograph Showing Bumped Outer Edge
on Ring 2 from AVCO 3DCP

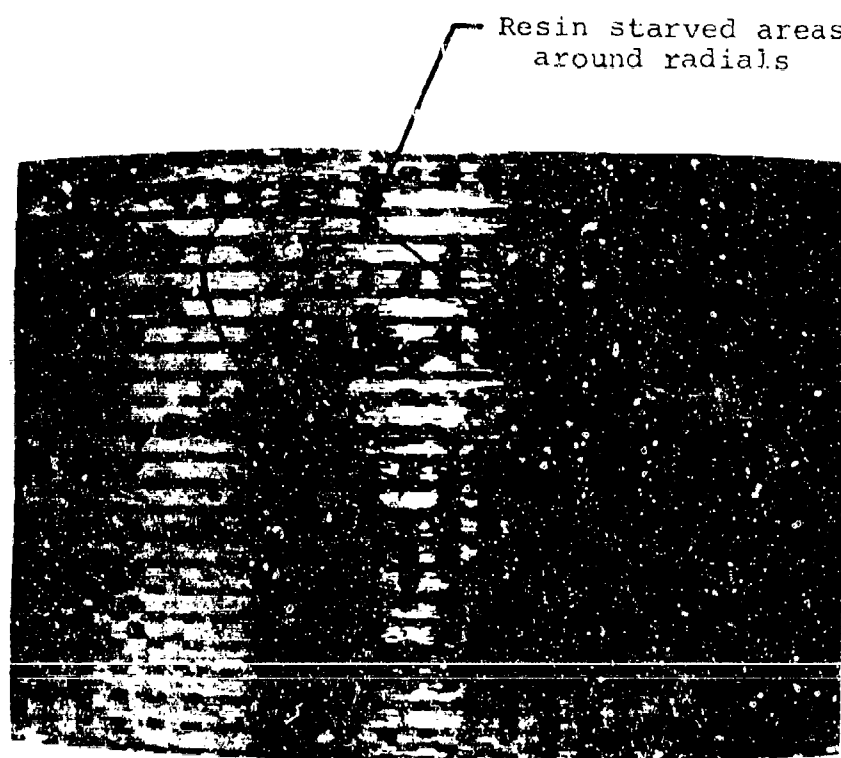
Figure 19. Photograph Showing Visual Resin-Starved Areas Around Radials in Ring 2 from AVCO 3DCP

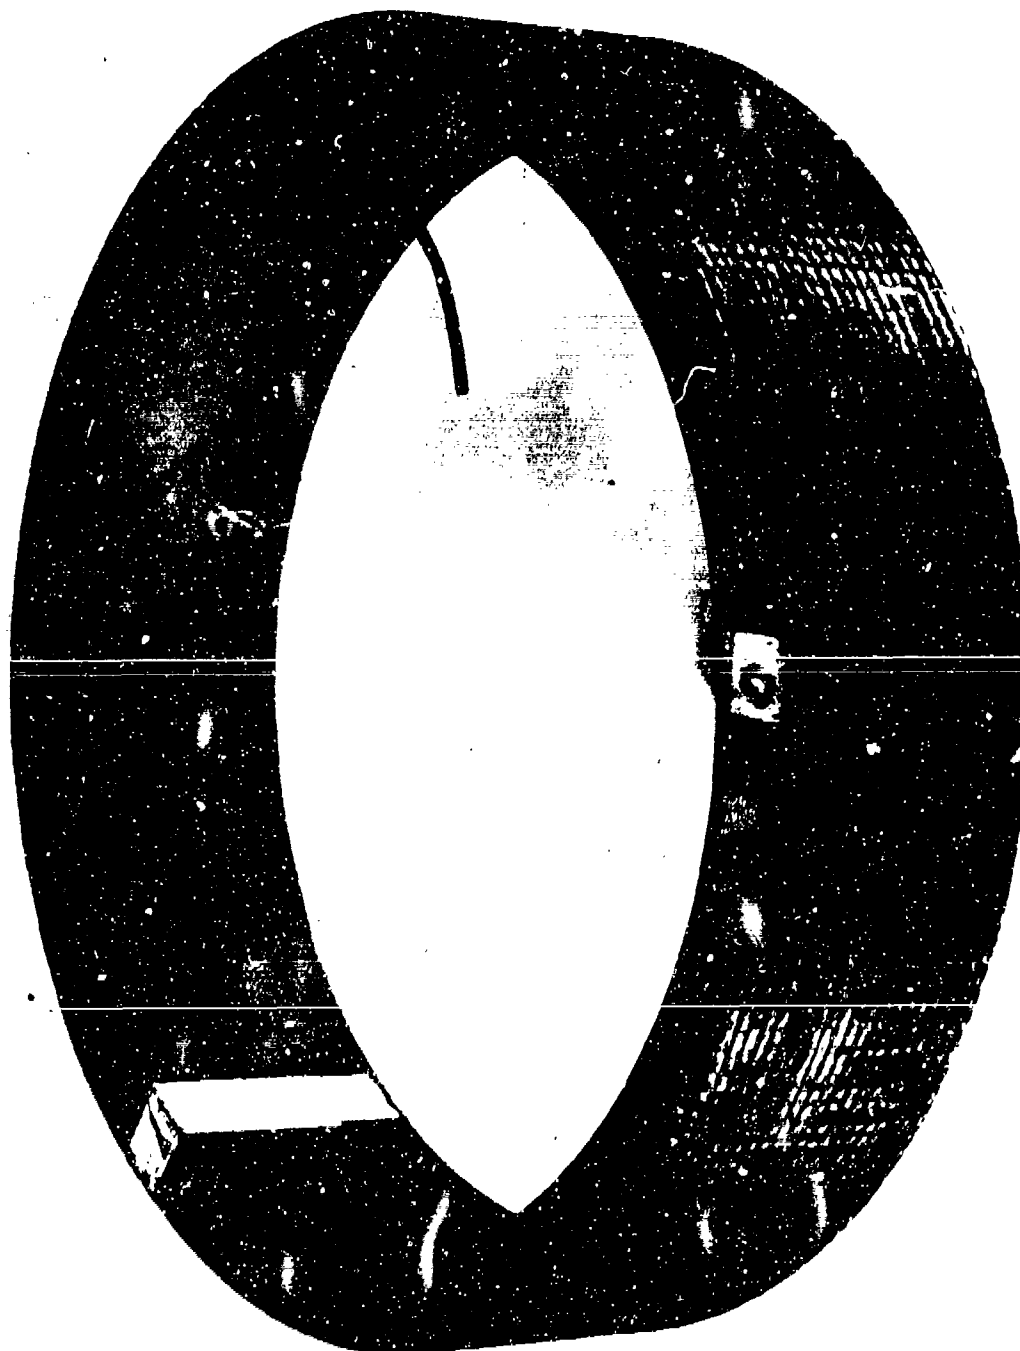
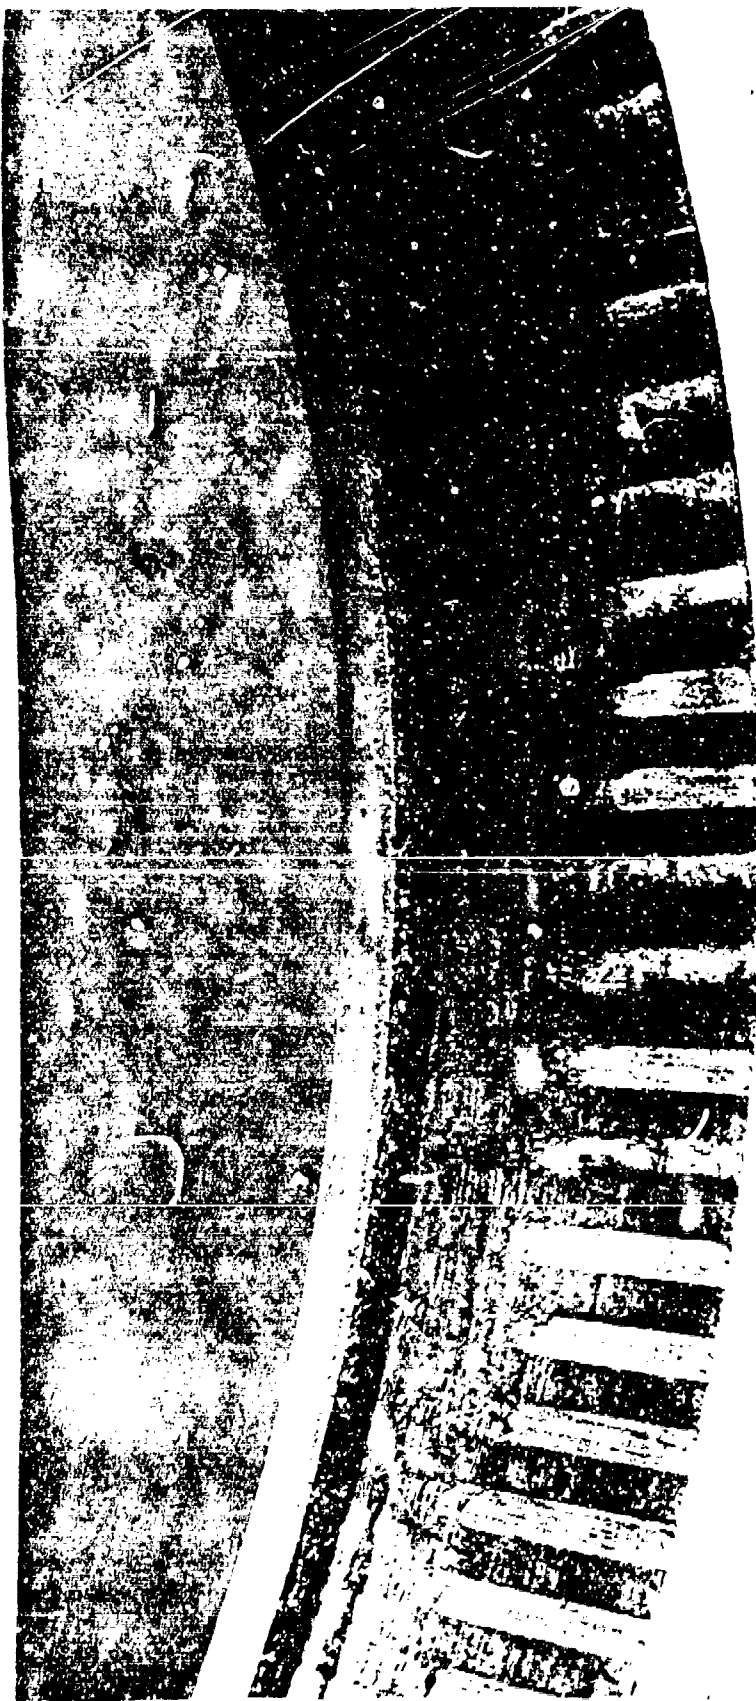
Figure 33. Photographs Showing As-Received Ring 1109-35-2 from AVCO 3bdc After Exposure

Structural change was visually apparent in both rings. Photographs showing the as-received rings are given in Figures 33 and 34. Generally, for both rings, the change consisted of raised or recessed and missing radials, cracking along local preexisting circumferential delams completely around the ring,

spalled sections of matrix and circumferential reinforcement (circs) over radials in edges, yarn lift from the front face, and discolorations (dark) on the front face. These and other changes are detailed in Table 5 and Figures 35 and 36. Absorption of trimethylpentane into edges of both exposed rings was higher in the exposed zone than out of the exposed zone. The only change indicated by axial X-ray was a 1-1/2-inch long circumferential low-absorptive alignment at 315°.

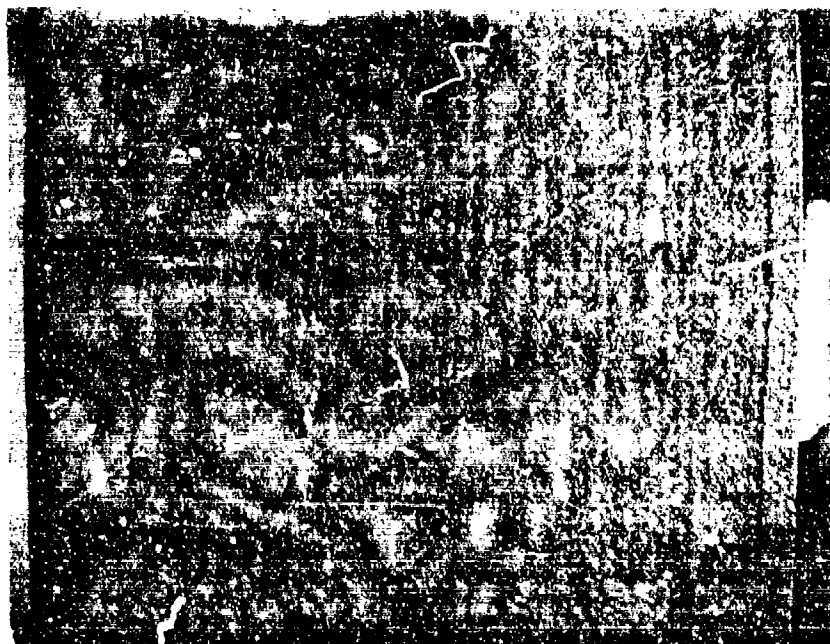
Material removal and discoloration in exposed zone located approximately 270-0-90°. Porosity and surface texture near normal.
